Johannes Hann Farm (Crookabout) 1200 Trevanion Road

Survey No. CARR-70

Maryland Historical Trust State Historic Sites Inventory Form

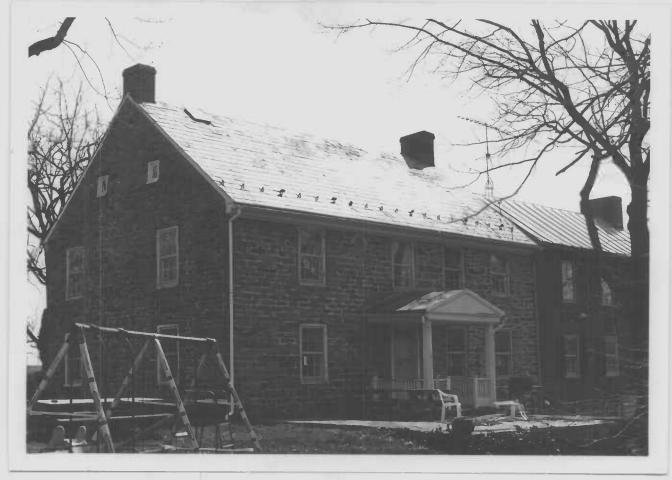
Johannes Hann Farm (Crockalout) 1200 Trevanion Road Carroll County, Maryland Photo: Kenneth M. Short Date April 1993 Neg Loc. : Maryland Historica I Trust house - north : west elevations

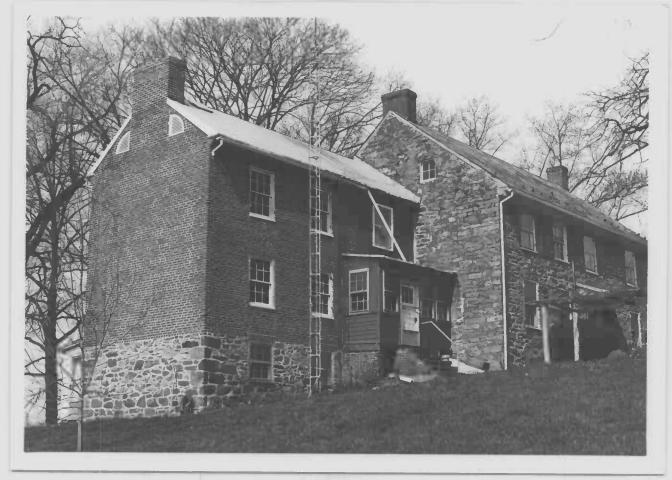
CARR-70 Johannes Harn Farm (Creckslant) 1200 Trevanion Road Carroll County, Maryland Photo: Kenneth M. Short Date: April 1993 Neg Loc. Maryland Historica I Trust house - South east elevations

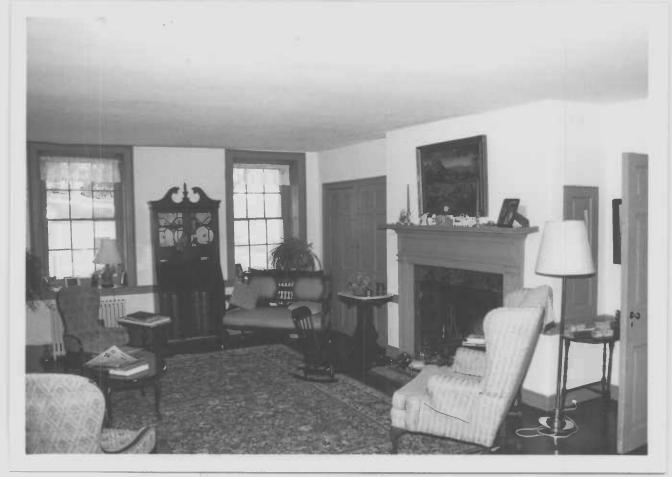
CAKK-70 Johannis Hours Farm- (Croscallans) 1200 Trevanion Boal Carroll Courty, maryland Photo Genneth M. Short Date April 1993 Neg Loc. ! Maryland Historica Trust interior - 1st Story, center room - south east : Southwest 4/12 elevations

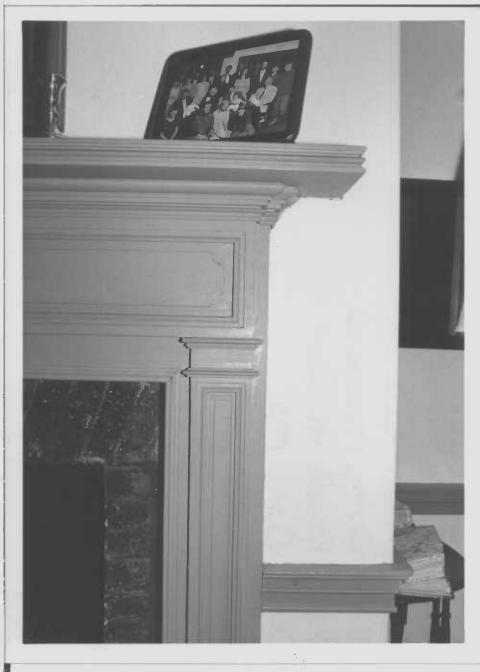
Johnnes Hann Farm (Crookabent) 1200 Trevanion Road Carroll County, Maryland Photo, Kenneth m. Short Date april 1993 Neg. Loc. : Maryland Historica / Trust interior-1st story, center room, southwest mantel detail 5/10

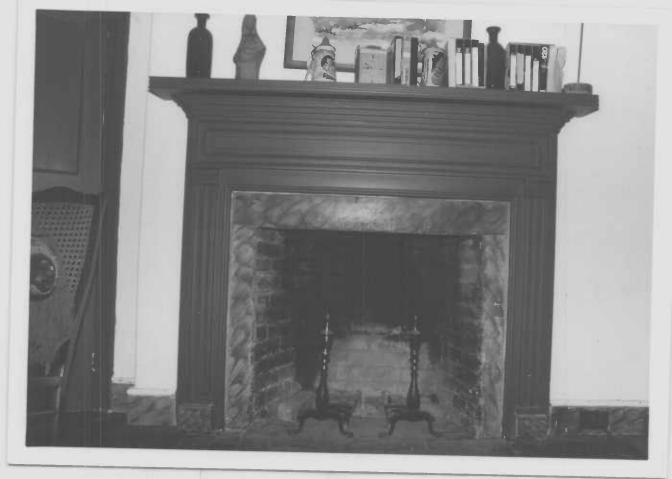
Johannes Hann Farr - (Crookaled) 1200 Trevanion Road Carroll County, Maryland Photo Kerneth M. Short Date: April 1993 Neg Loc: Maryland Historica / Trost interior- and story, center room mantel 6/2

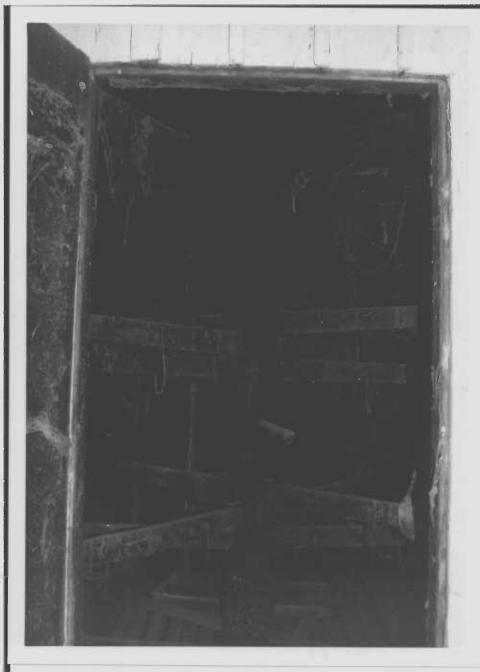
South of the summer kitchen is a smokehouse with a rubble stone foundation, board-and-batten siding, and a gable roof with an east-west ride and corrugated metal. The north elevation has a vertical board door on strap hinges. The structure appears to be made of sawed logs, and has a large summer beam that runs east-west and holds an octagonal tree that pivots. The tree has horizontal boards approximately 1x4 inches that pass through mortises in the tree. There are three boards at the bottom, creating six arms, and the boards are set one above the other. There are three more boards in the center of the tree, and another tier of three boards at the top. Each arm has three metal pegs for hanging meat. There is a second summer beam, at the top, that runs east-west

and holds the top of the tree in place. There are sawn rafters, mitered at the ridge, with lath and wood shingles under the current metal covering. The floor of the building is wood boards. The south elevation of the foundation has a short, beaded-edge vertical board door. The foundation is completely open, instead of having a small firebox.

bhonres Harry Farm (Crookabout) 1200 Trevarion Road Carroll Country, Maryland Photo: Kenneth in Short Date: April 1993 Neg. Loc.: Maryland Historical Trust Smokehouse-interior

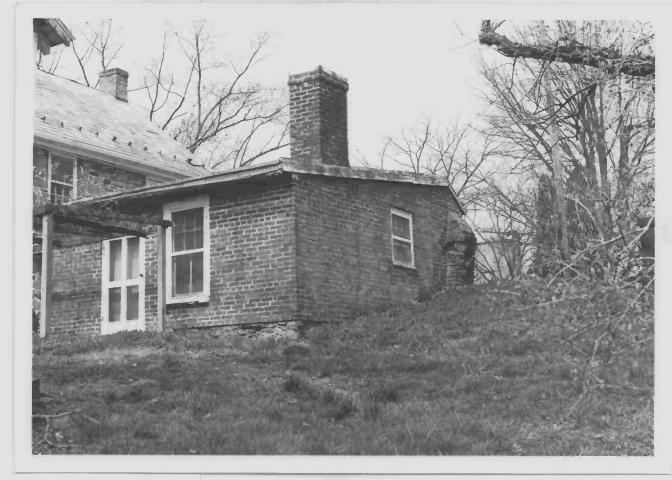
Just east of the house is a brick summer kitchen and ground cellar built in two stages but now under the same roof. The northern half is the ground cellar, is older and appears to have had a gable roof with an east-west ridge, but only the north half of the roof remains. The southern half of the gable roof has been rebuilt with a long, low pitch, re-using the original ridge. The bricks on the southern addition have been carried northward over the original gable end to fill in. Both halves of the roof now have standing-seam metal. The west elevation of the cellar has a vertical board door in a beaded-edge frame in the north bay. The north elevation has exposed rafter ends. The western third of the building projects northward about two feet. East of the ground cellar structure is a mound with the cellar underneath, and a brick vent stack on both the east and west ends of the mound. The vents are about three feet above ground, with an opening on the east elevation. The western vent is up against the east wall of the above ground structure. The door opens into a wide vestibule with a narrow wood staircase ahead that leads down, under the east wall of the structure to the cellar. The cellar has a brick floor, rubble stone walls, and a brick barrel vault, and is plastered on the interior.

The southern summer kitchen addition is 6-1 common bond brick. The west elevation is two bays, with a vertical board door in a flat frame to the north and a 6/3 sash with wood sill, beaded interior edge frame, and brick jack arch, in the south bay. The south elevation has a vertical-board door in the west bay, with a beaded interior edge on the frame and a brick jack arch. The east bay has a 6/2 sash in a pegged mortise-and-tenon frame with an ovolo moulding on the outer edge, and a large wood sill. The east elevation has a 6/3 in the north bay, with a beaded-interior-edge frame, and an interior brick chimney over the south bay. The kitchen is one open room with a large brick fireplace on the east wall, to the south. The fireplace has a recessed throat at the back of it, a wood mantle tree, and a crane. There are exposed sawn rafters, about 2x5% inches, with board sheathing.

CARR- 70 Stones How Farm (Crakets +) 1200 Trevarion Road Carroll County, maryland Photo: Kenneth M. Short Date: April 1993 Neg Loc.; Maryland Historica I Trust Summer Kitchen : ground cellar

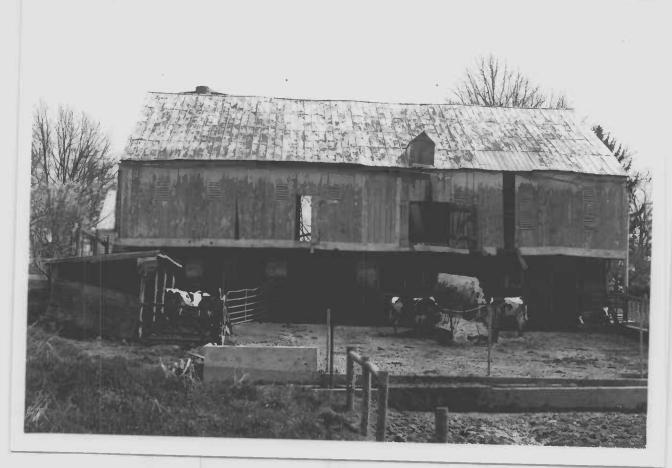
Johnnes Harn Farm (Grookalut) 1200 Trevanion Road Carroll County, Maryland Photo: Kerneth M. Short Date: April 1993 Neg. Loc .: Maryland Historical Trost bank barn - south : east elevations

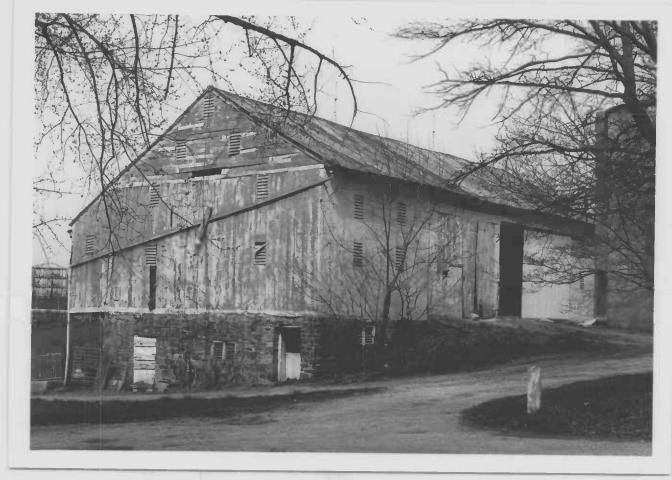
CARR-70 Johnnes Hann For (Crosphant) 1200 Trevanion Road Carroll County, Maryland Photo: Kenneth m. Short Date: April 1993 Neg Loc: Maryland Historical Trust bank barn - South ; east elevations

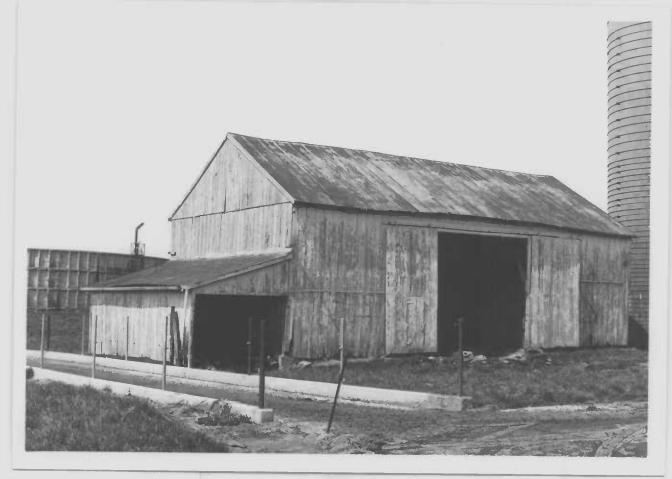
CHIKR-70 Johannis Hann Farm (Crascabola) 1200 Trevanion Road Carroll County, Maryland Photo: Kenneth M. Short Date: April 1993 Neg. Loc : Maryland Historical Trust South : east elevations

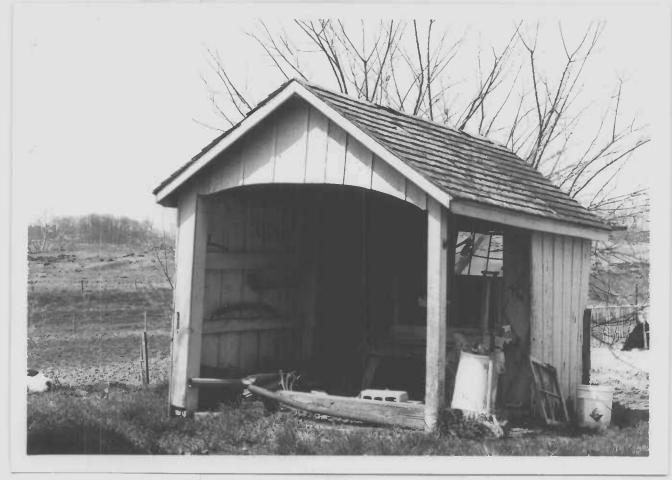
South of the barn is a one-story frame tool shed with board-and-batten siding and a gable roof of wood shingles with a northwest to southeast ridge. The southeast end and eastern half of the northeast side are open. There is a six-light sash on the northwest. The frame is circular-sawn, as are the rafters, which have a ridge beam and tie beams nailed to them. South of the tool shed is another shed with a CMU foundation and vertical board sheathing. The south end of the shed is narrow, has a sawn frame, a shed roof with corrugated metal, and a door on the east with clipped top corners. The north end of the shed also has a sawn frame, a gable roof with north-south ridge, and is open on the east. The north elevation has a beaded-edge vertical board door in the center, with a five-light sash to the west. The west elevation has two 2/2 sash. East of the barn is a wagon shed/corn crib, with the crib on the west. It has a gable roof of inverted-Vseam metal, with a north-south ridge, and a concrete foundation. It is built with a heavytimber braced frame and pegged mortise-and-tenon joints. The south elevation has a door on the west crib with horizontal slots, vertical, beaded-edge-and-center board siding, and a matching wagon door on rollers. There is a six-light sash on the gable end. Attached to the east side is a long shed with a CMU foundation, German siding on a circular-sawn 2x4 frame, and a corrugated metal gable roof with an east-west ridge. This shed is open on the south. East of the shed is a poultry house with a concrete foundation, German siding, and a gable roof with asphalt shingles and an east-west ridge.

CARR-70 Johannes Hann Farm (Crockallout) 1200 Trevanion Road Carroll Courty, Maryland Photo Kerneth M. Short Date April 1993 Neg. Loc Maryland Historica / Trust Tool Shell- southeast ; northeast elevations
